**Township of South Stormont**  
ACTION REQUEST  
Fire and Rescue Department

**To:** Council  
**From:** Morris Lamer, Fire Chief  
**Date of Meeting:** June 28, 2023  
**Subject:** Damaged Tanker – Station No. 3

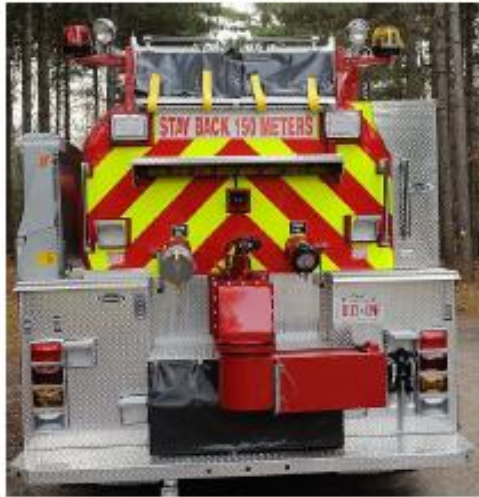
**CURRENT BACK OF TRUCK**

**Changes to current set up**

- Remove hose reel compartment
- Replace steps with folding ladder
- Relocate scene lights
- Remove ladder and hard suction hose compartment

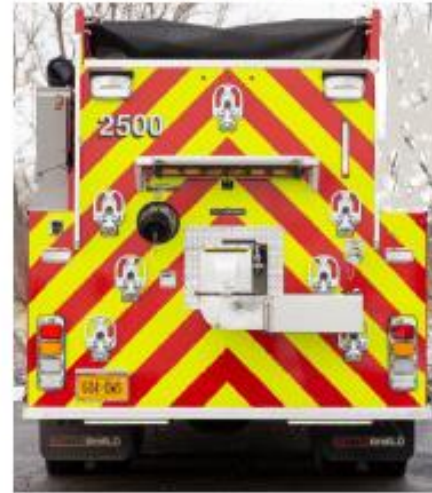
**PROPOSED BACK OF TRUCK (example only)**

- Replace aluminum tank with Poly tank (tank will not be exposed to elements – Dry side build design)
- Relocate traffic advisor and back up camera
- Replace hard covers with vinyl black tarp (old covers do not fit new body)
- Add Max Vision tank level gauge

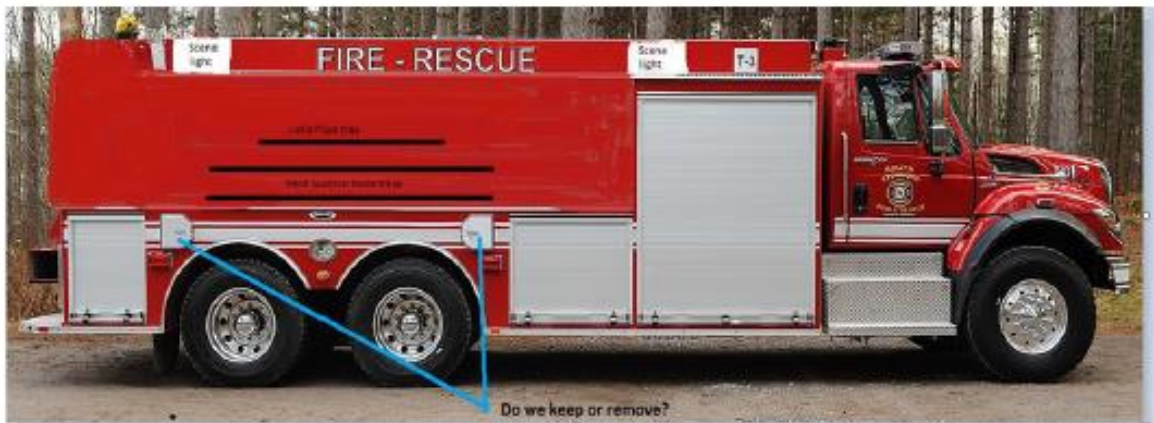
**Changes to this side**

- Ladder and hard suction hose compartment removed.
- Scene lights relocated to top of body
- Holly pipe and Hard suction hose trays for 6" on wall.
- Do you need the cylinder storage tubes?
- Upgrade reflective to new style – black and gold leaf
- Remove side camera
- Remove pump panel and plumbing (pump will sit on a tray and there will be a Tank to Pump 4" connection from tank)
- All compartments will now be squared off and have straight rear walls.
- Trays and shelves that can be reused will be reused
- Body extended to accommodate back of truck
- Beacon emergency light will be installed at rear top corner of body

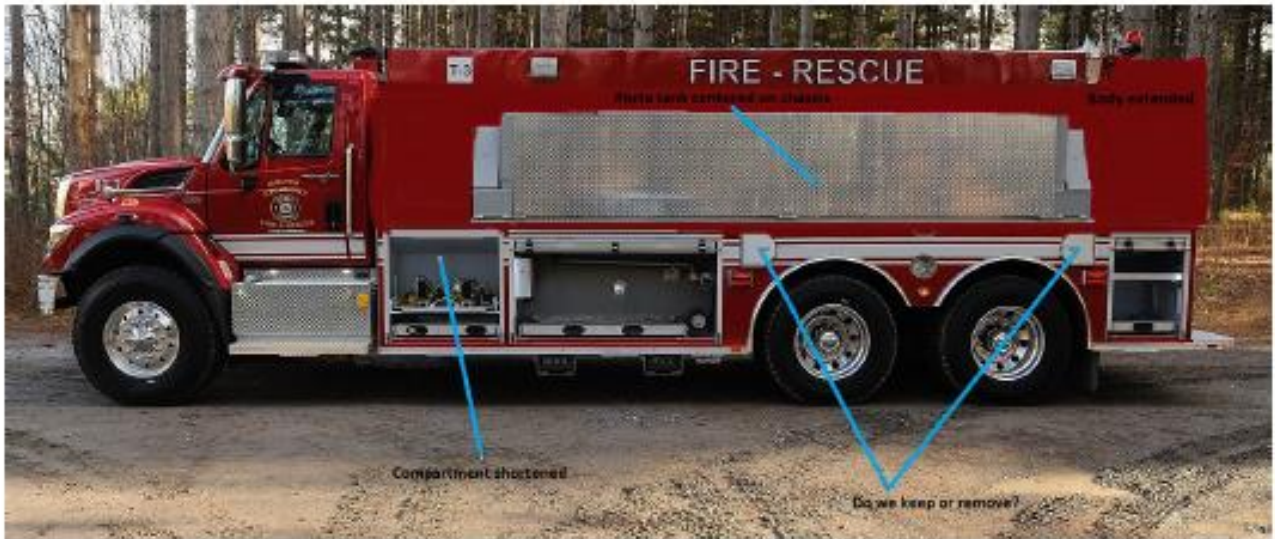
Changes to this side

- Porta tank centered on body
- R1 compartment shortened
- Do you need the cylinder storage tubes?
- Body extended to accommodate back of truck
- Beacon emergency light will be installed at rear top corner of body.
- Do you need the cylinder storage tubes?
