Former Beaches Pub Property Environmental Site Assessments Executive Summary

Presentation to Council
Township of South Stormont

David Hodgson, P.Eng., Malroz Engineering Inc.

Phase One ESA
15945 County Road 2, Long Sault, Ontario

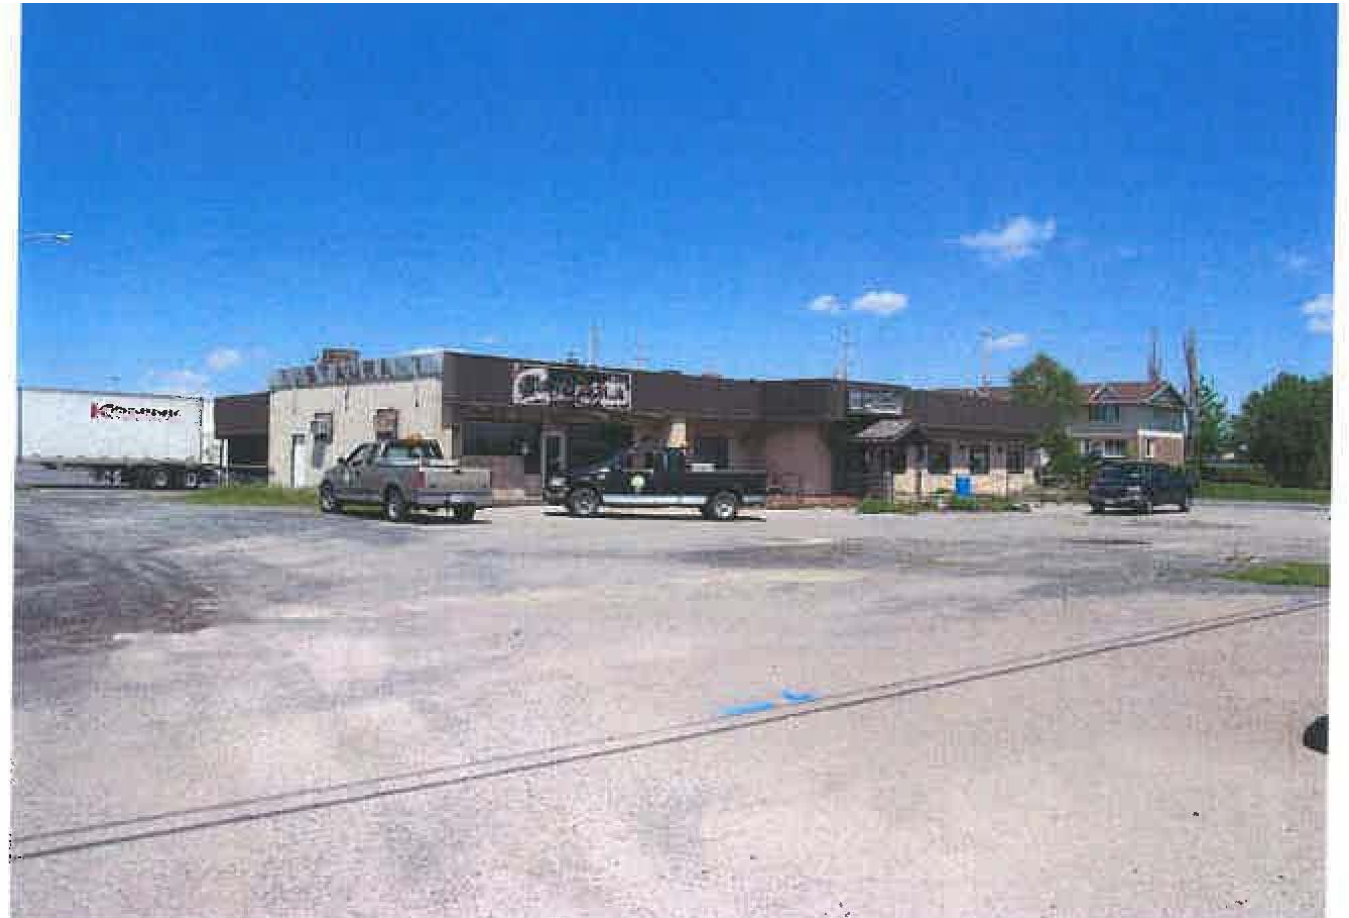
- Formerly Beaches Pub, Closed circa
- Previously a gas bar & garage until 1970s
- Known brownfield – Preliminary Phase 1 & 2 Environmental Site Assessment (ESA) 2004
- RFEOI in 2016
- Purpose: Assess Environmental Conditions and Related Risk

(Source: HSP Engineering, preliminary Phase 1 & 2 Environmental Site Assessment, June 2004)

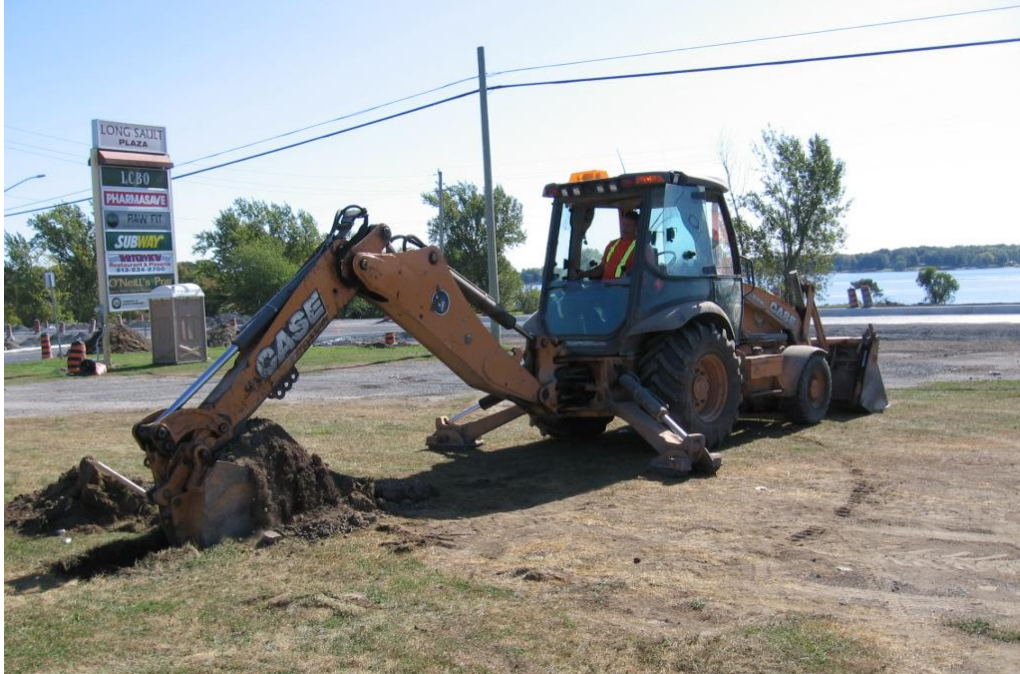
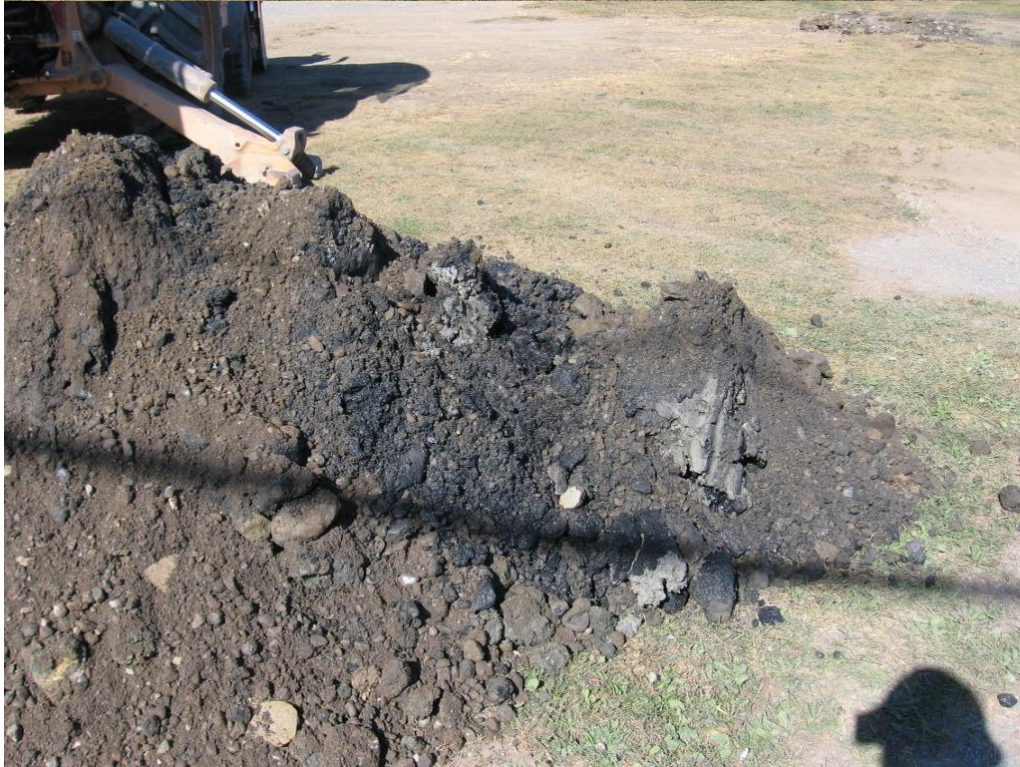
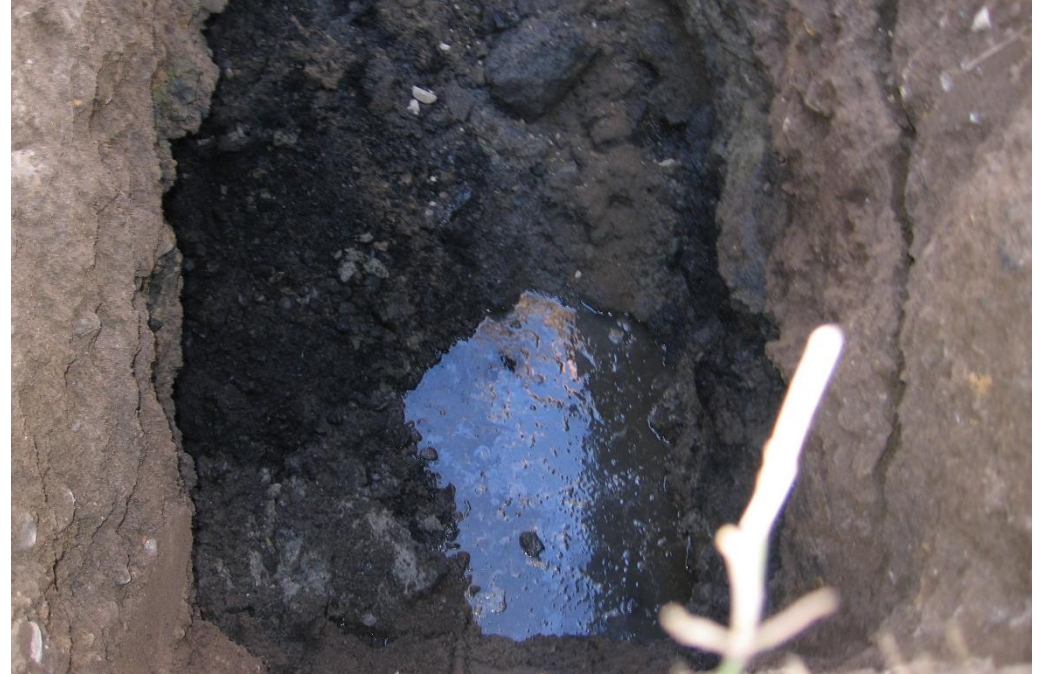
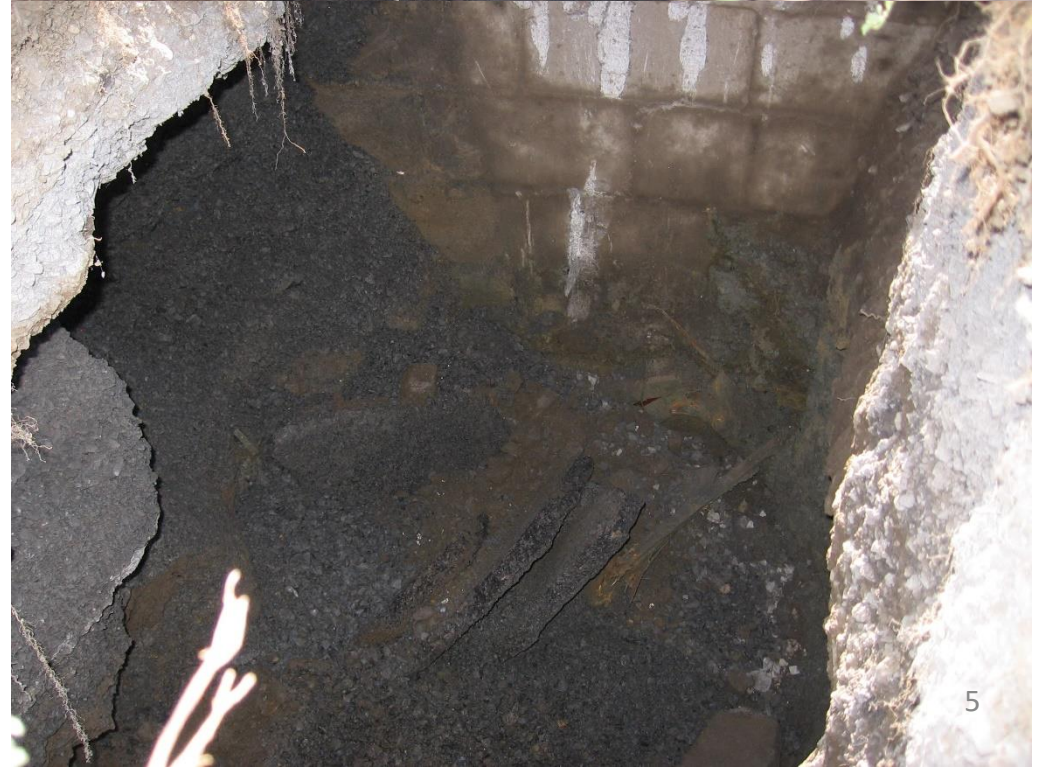
- Reviewed Preliminary Phase 1 & 2 ESA by HSP (2004)
- Initial testpitting completed in 2017

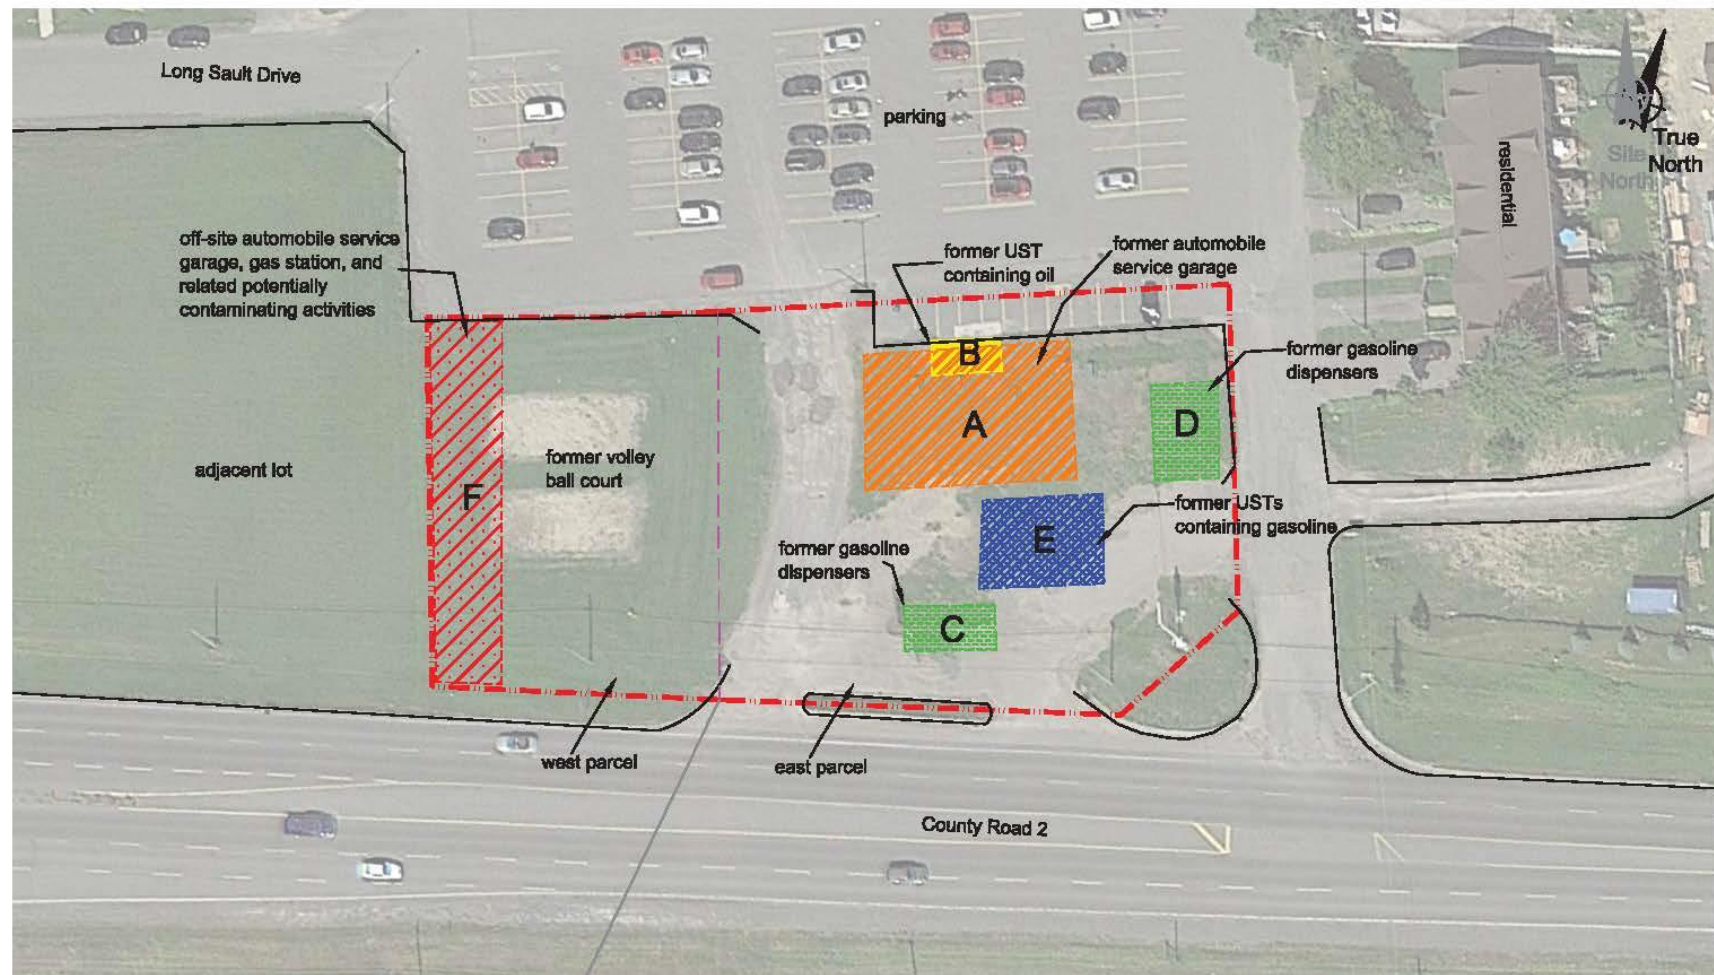
File: 1022-111.03		<h1>Figure 4</h1>

- approximate property boundary
- boundary between east parcel and west parcel
- edge of pavement

- A former automobile service garage and fill area (PHC, VOC, PAH, Metals)
- B former UST containing oil (PHC, VOC, PAH, Metals)
- C/D former gasoline dispensers (PHC, VOC)
- E former USTs containing gasoline (PHC, VOC, Metals)
- F off-site automobile service garage, gas station, and related potentially contaminating activities (PHC, VOC, PAH, Metals)

<h2 style="text-align: center;">Areas of Potential Environmental Concern</h2>					
<p style="text-align: center;">Phase One ESA 15945 County Road 2, Long Sault, Ontario</p>

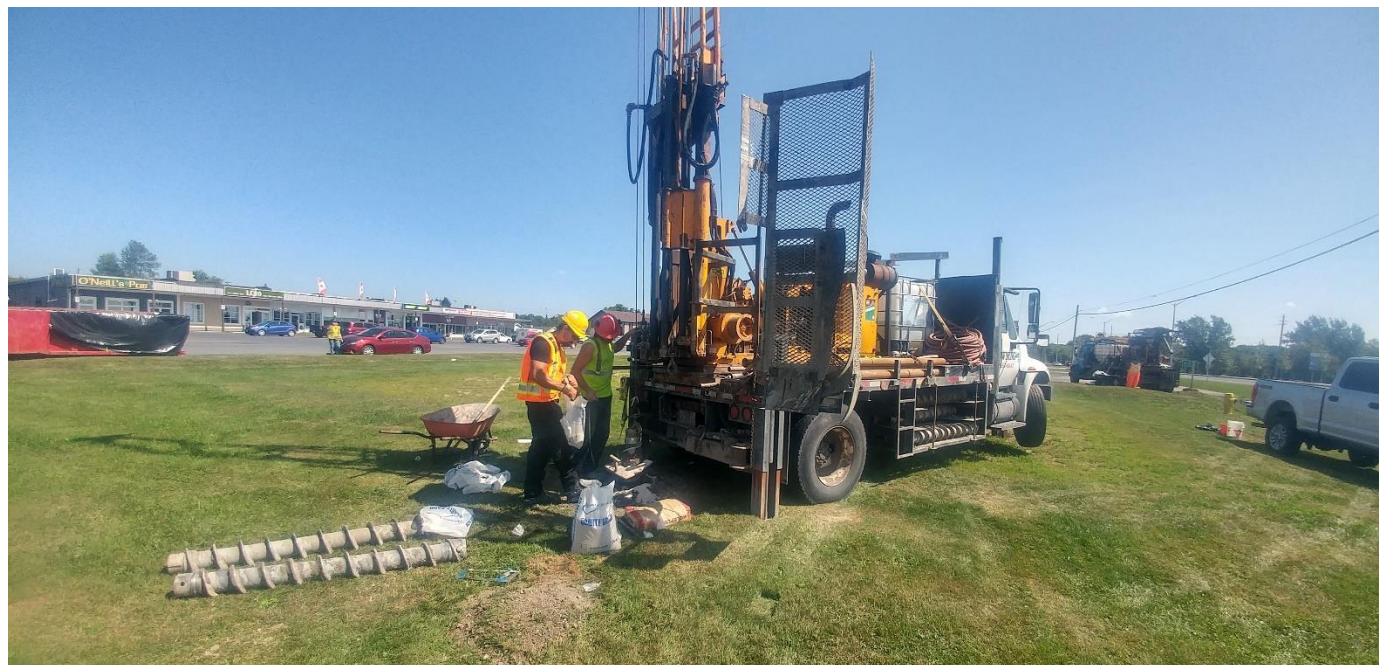
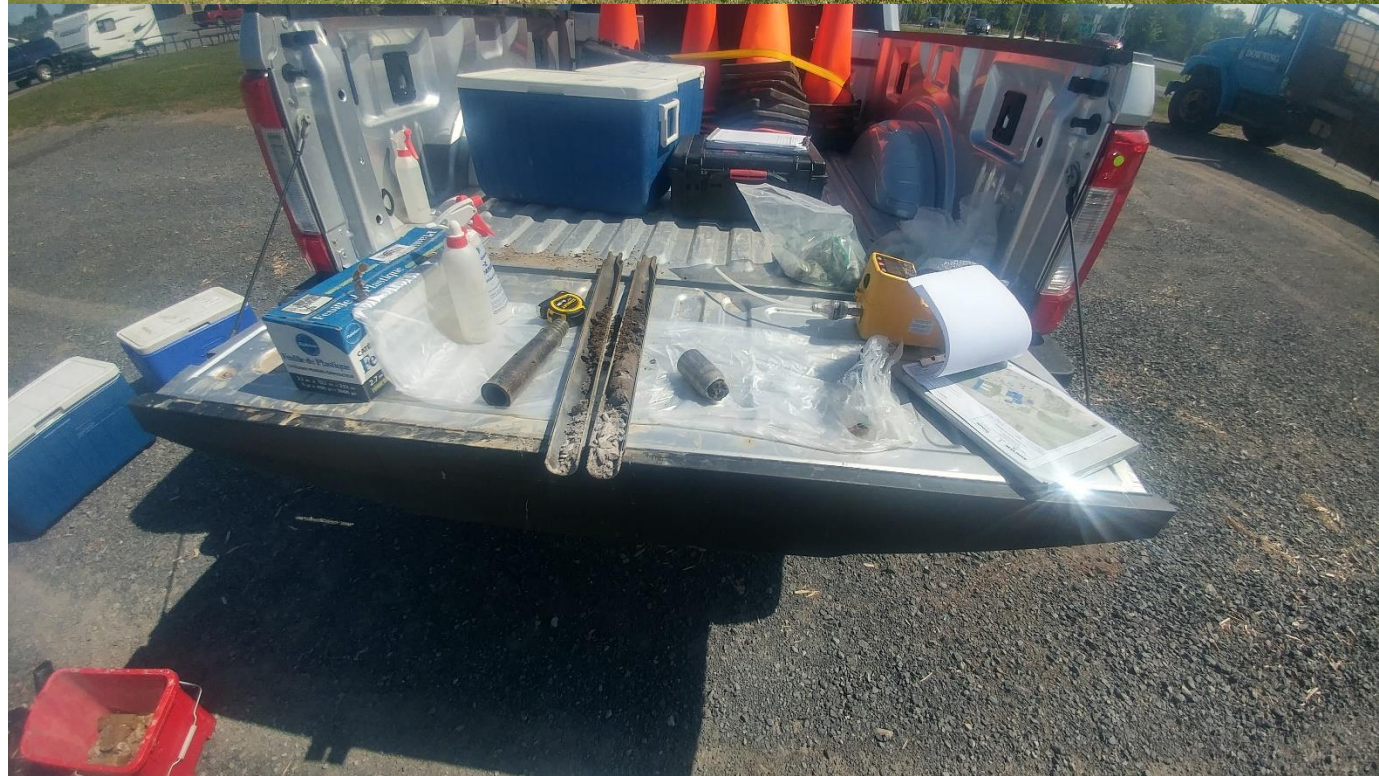
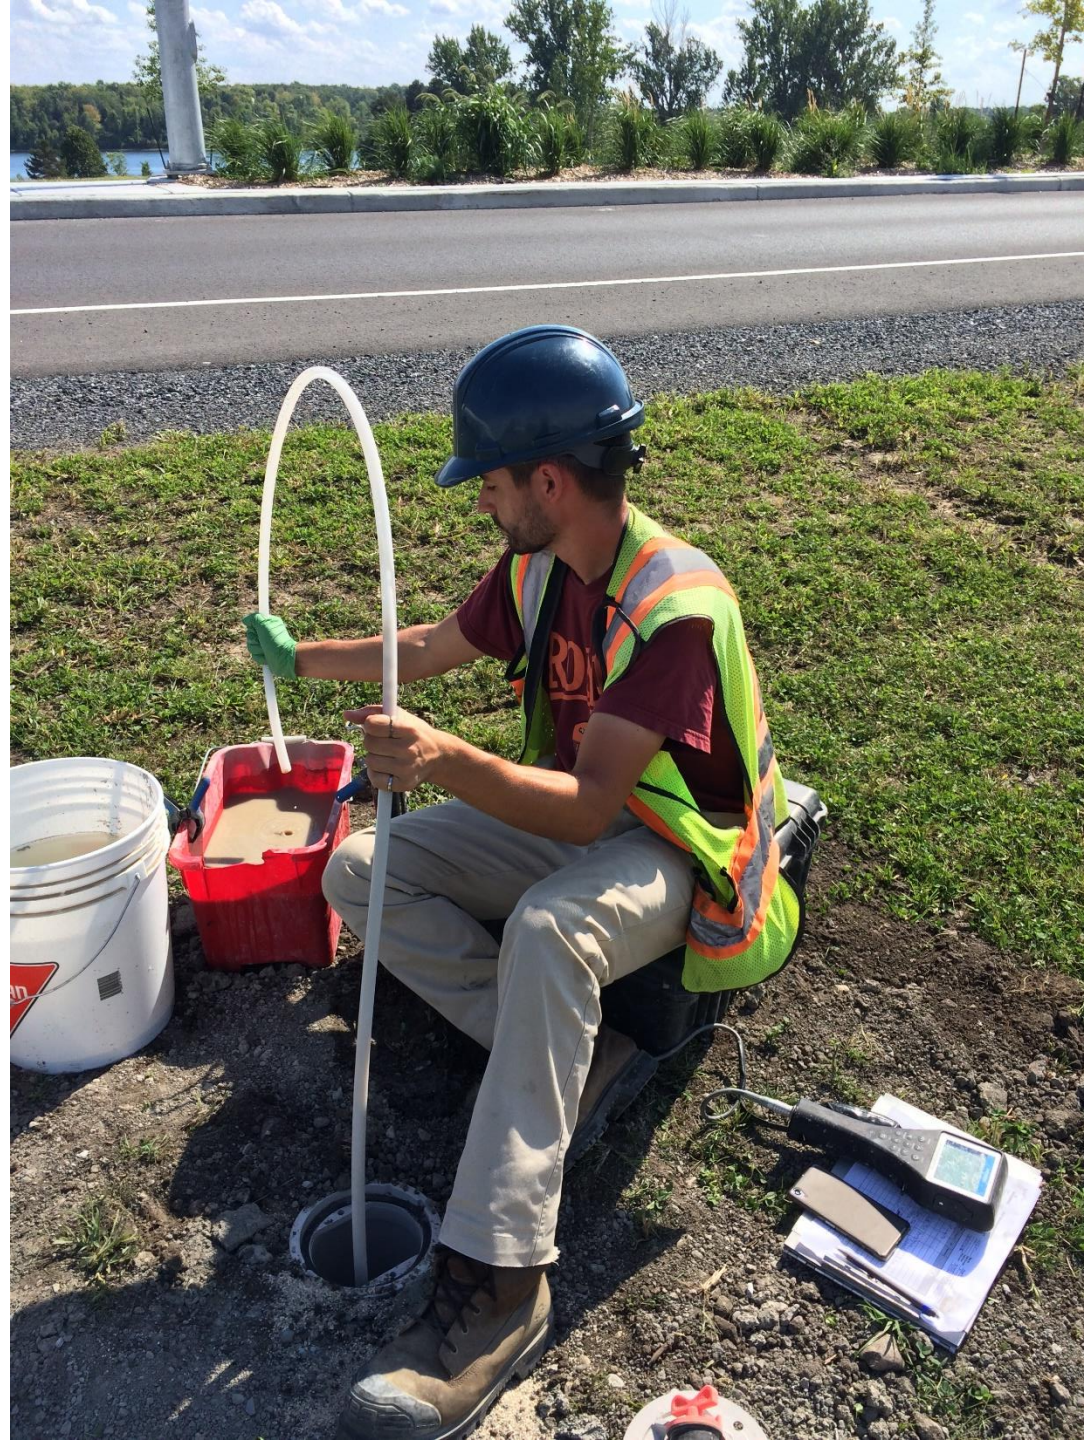
- Plan was developed based on results of the Phase 1 ESA
- Scope:
 - a geophysical survey
 - boreholes for soil sampling
 - install of groundwater monitoring wells
 - soil and groundwater sampling
 - testpitting to visually assess geophysical anomalies
- Completed to RSC Standards, but some additional work will be needed to support a subsequent RSC

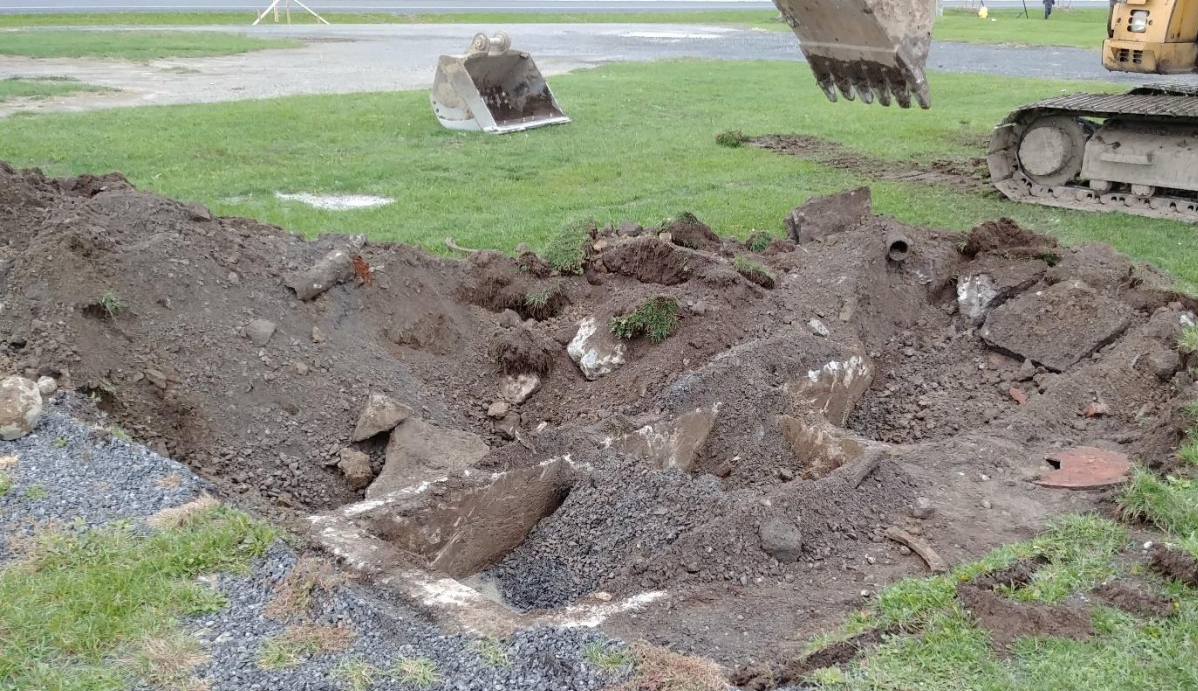
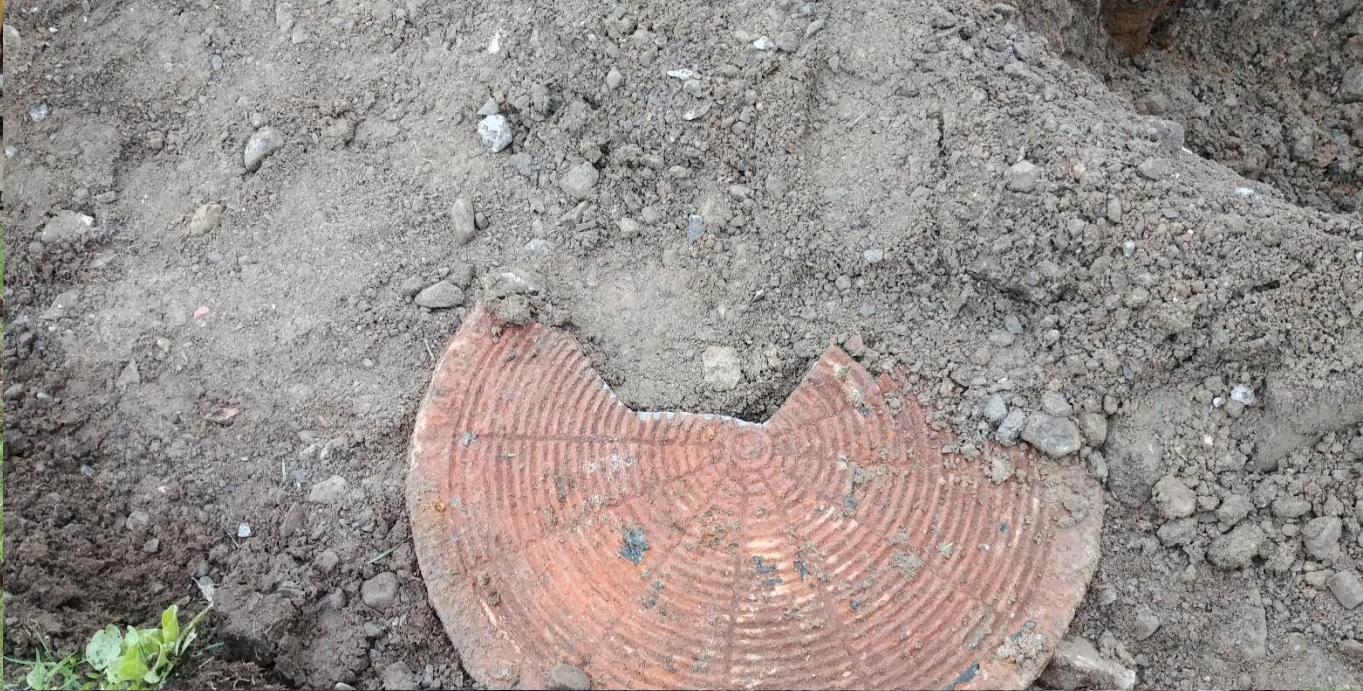
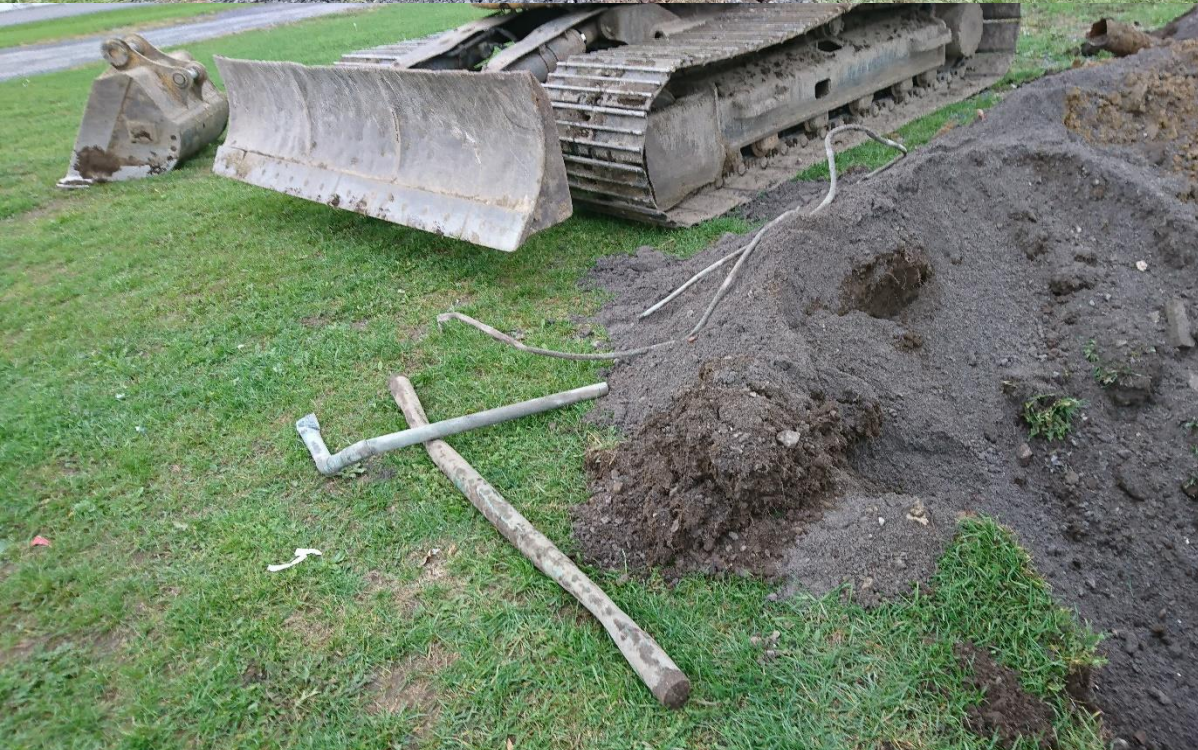
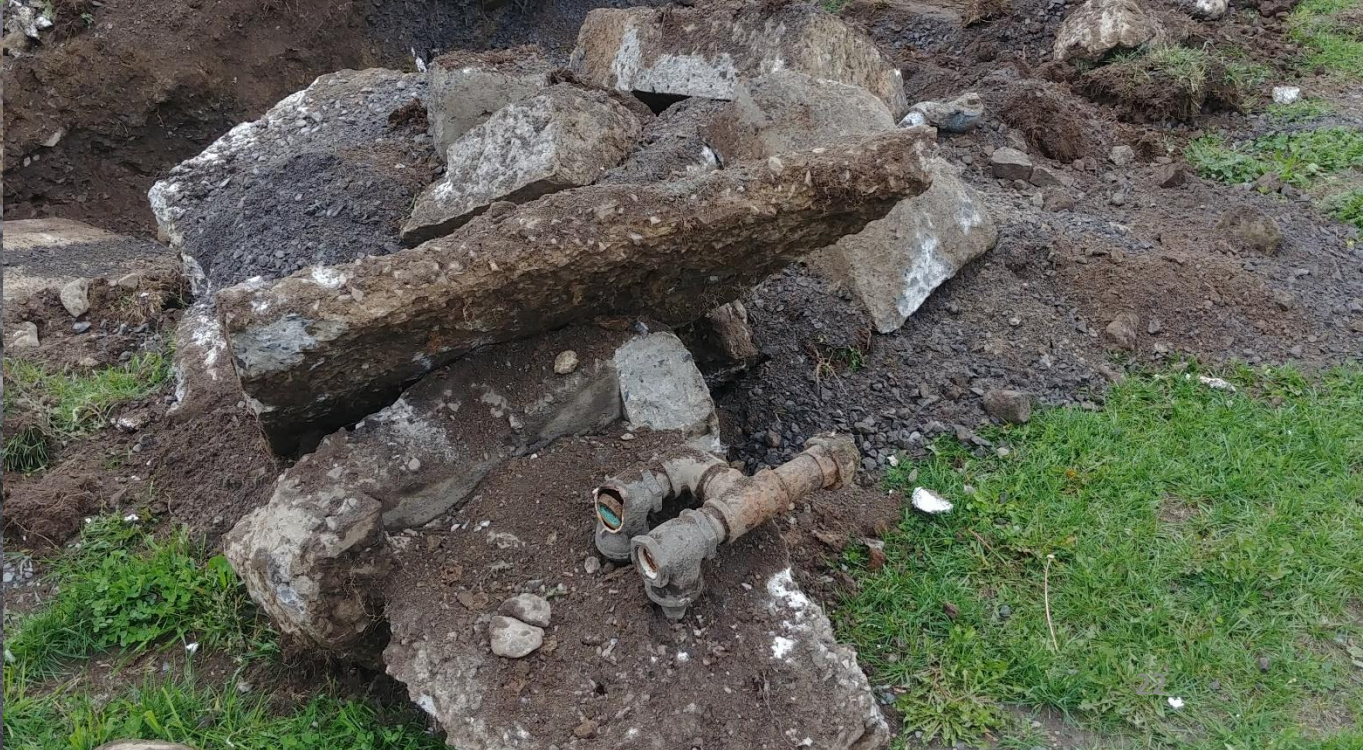
- Stringent environmental standards due to shallow groundwater encountered at the site (< 2 metres below grade)
- Soil & groundwater contamination
 - Petroleum-related impacts (PHC, BTEX, PAH)
- Four geophysical anomalies (potential tanks or other buried metal objects)

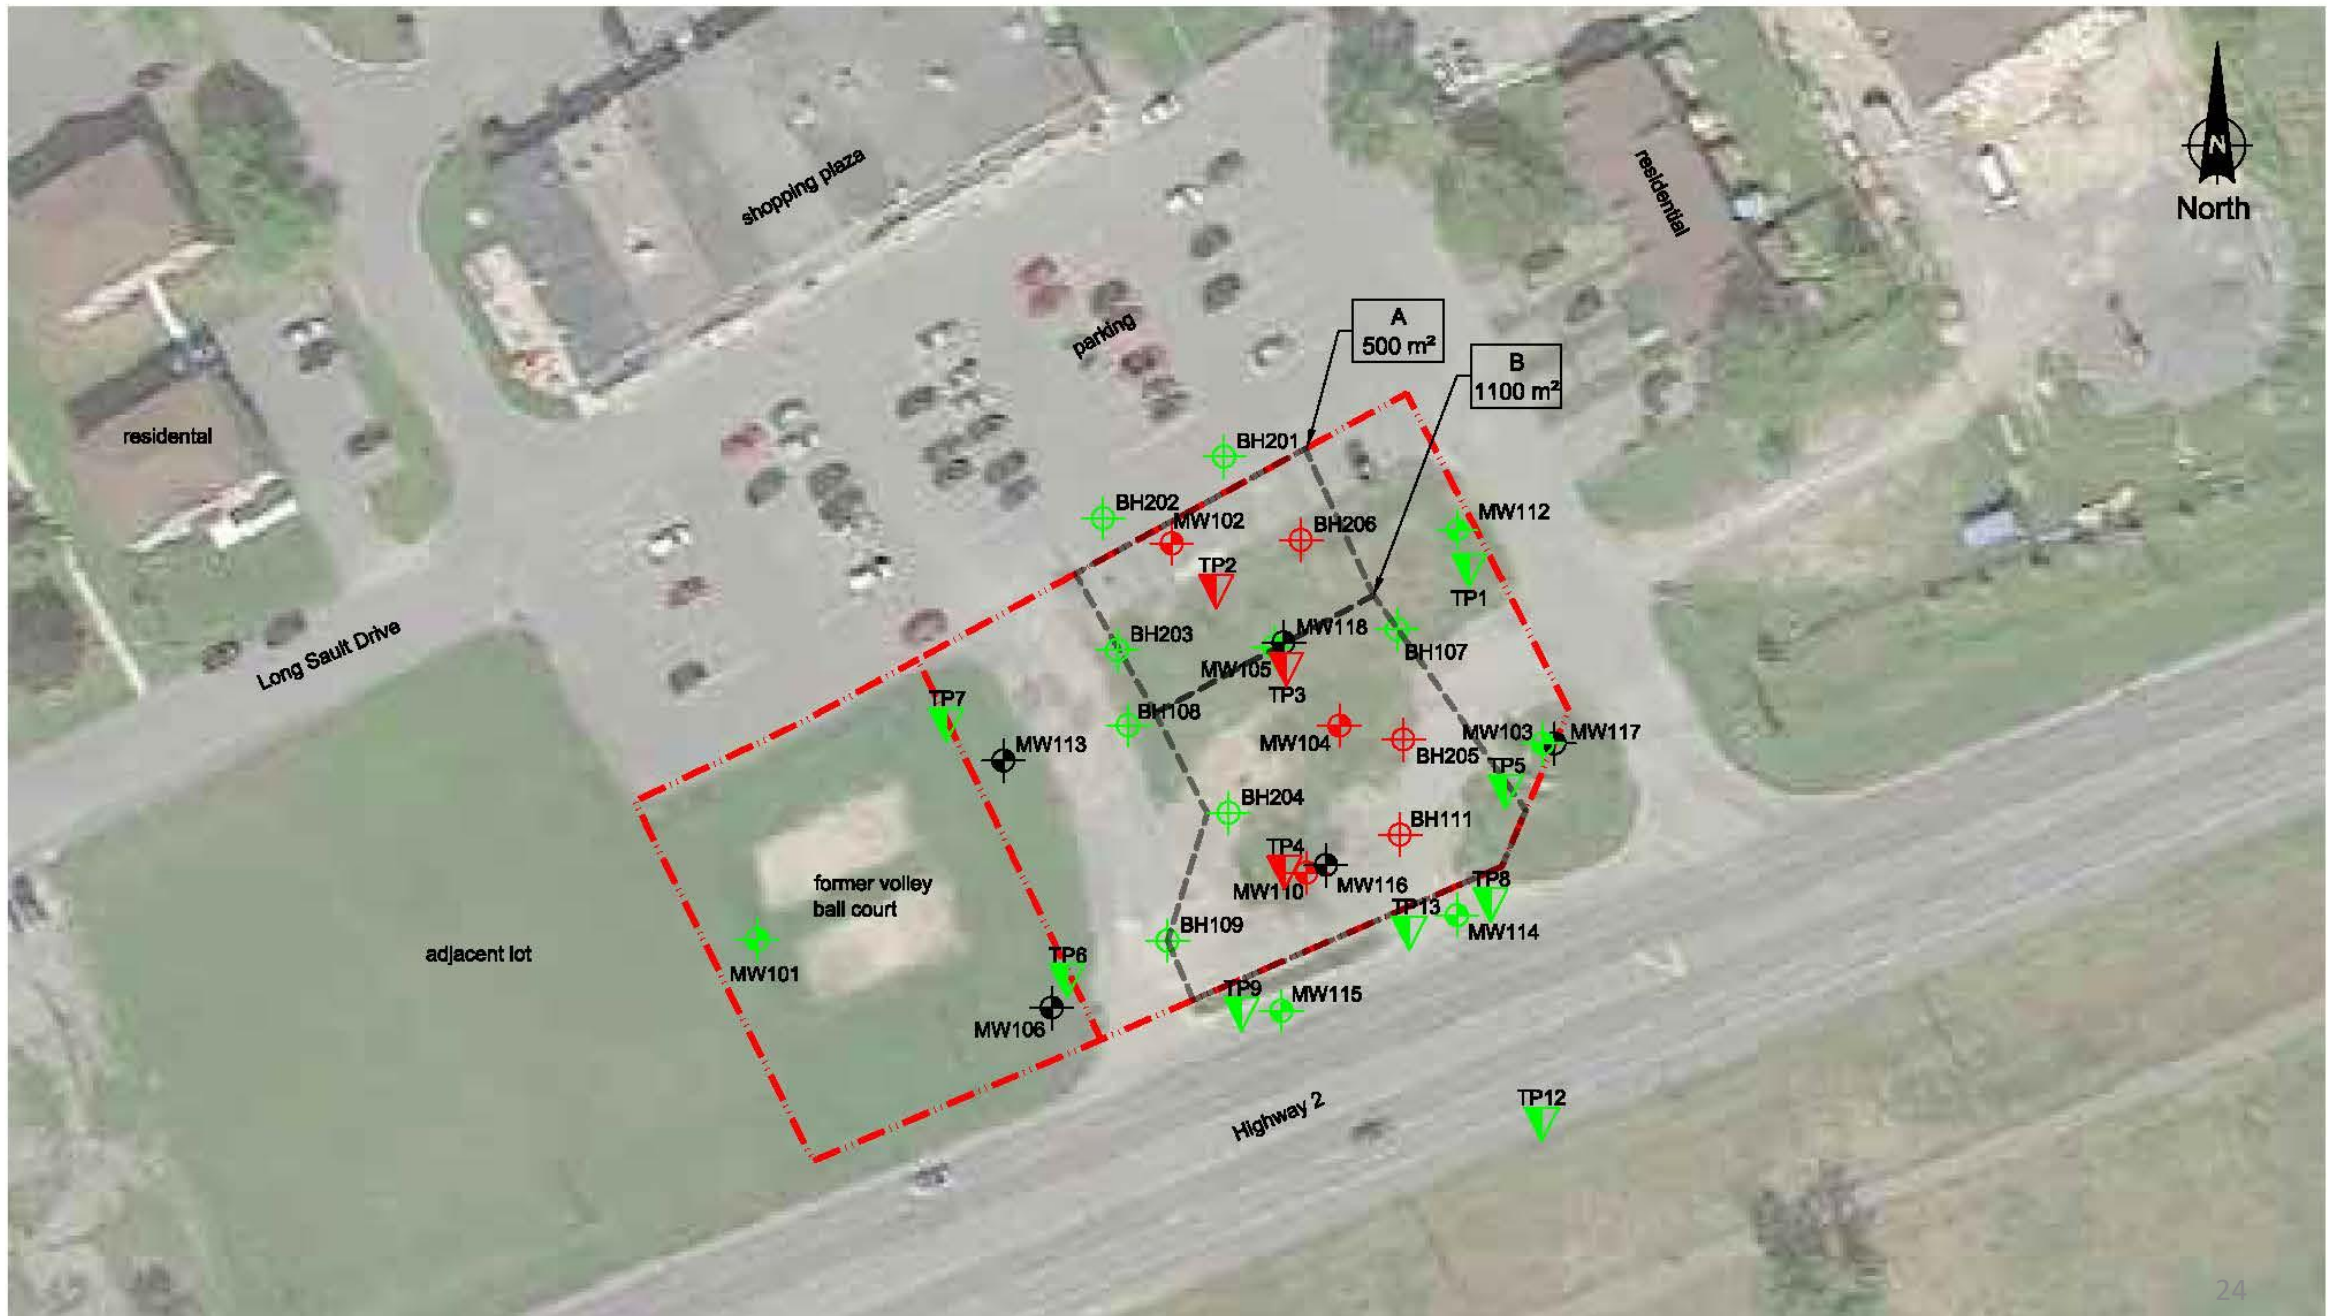
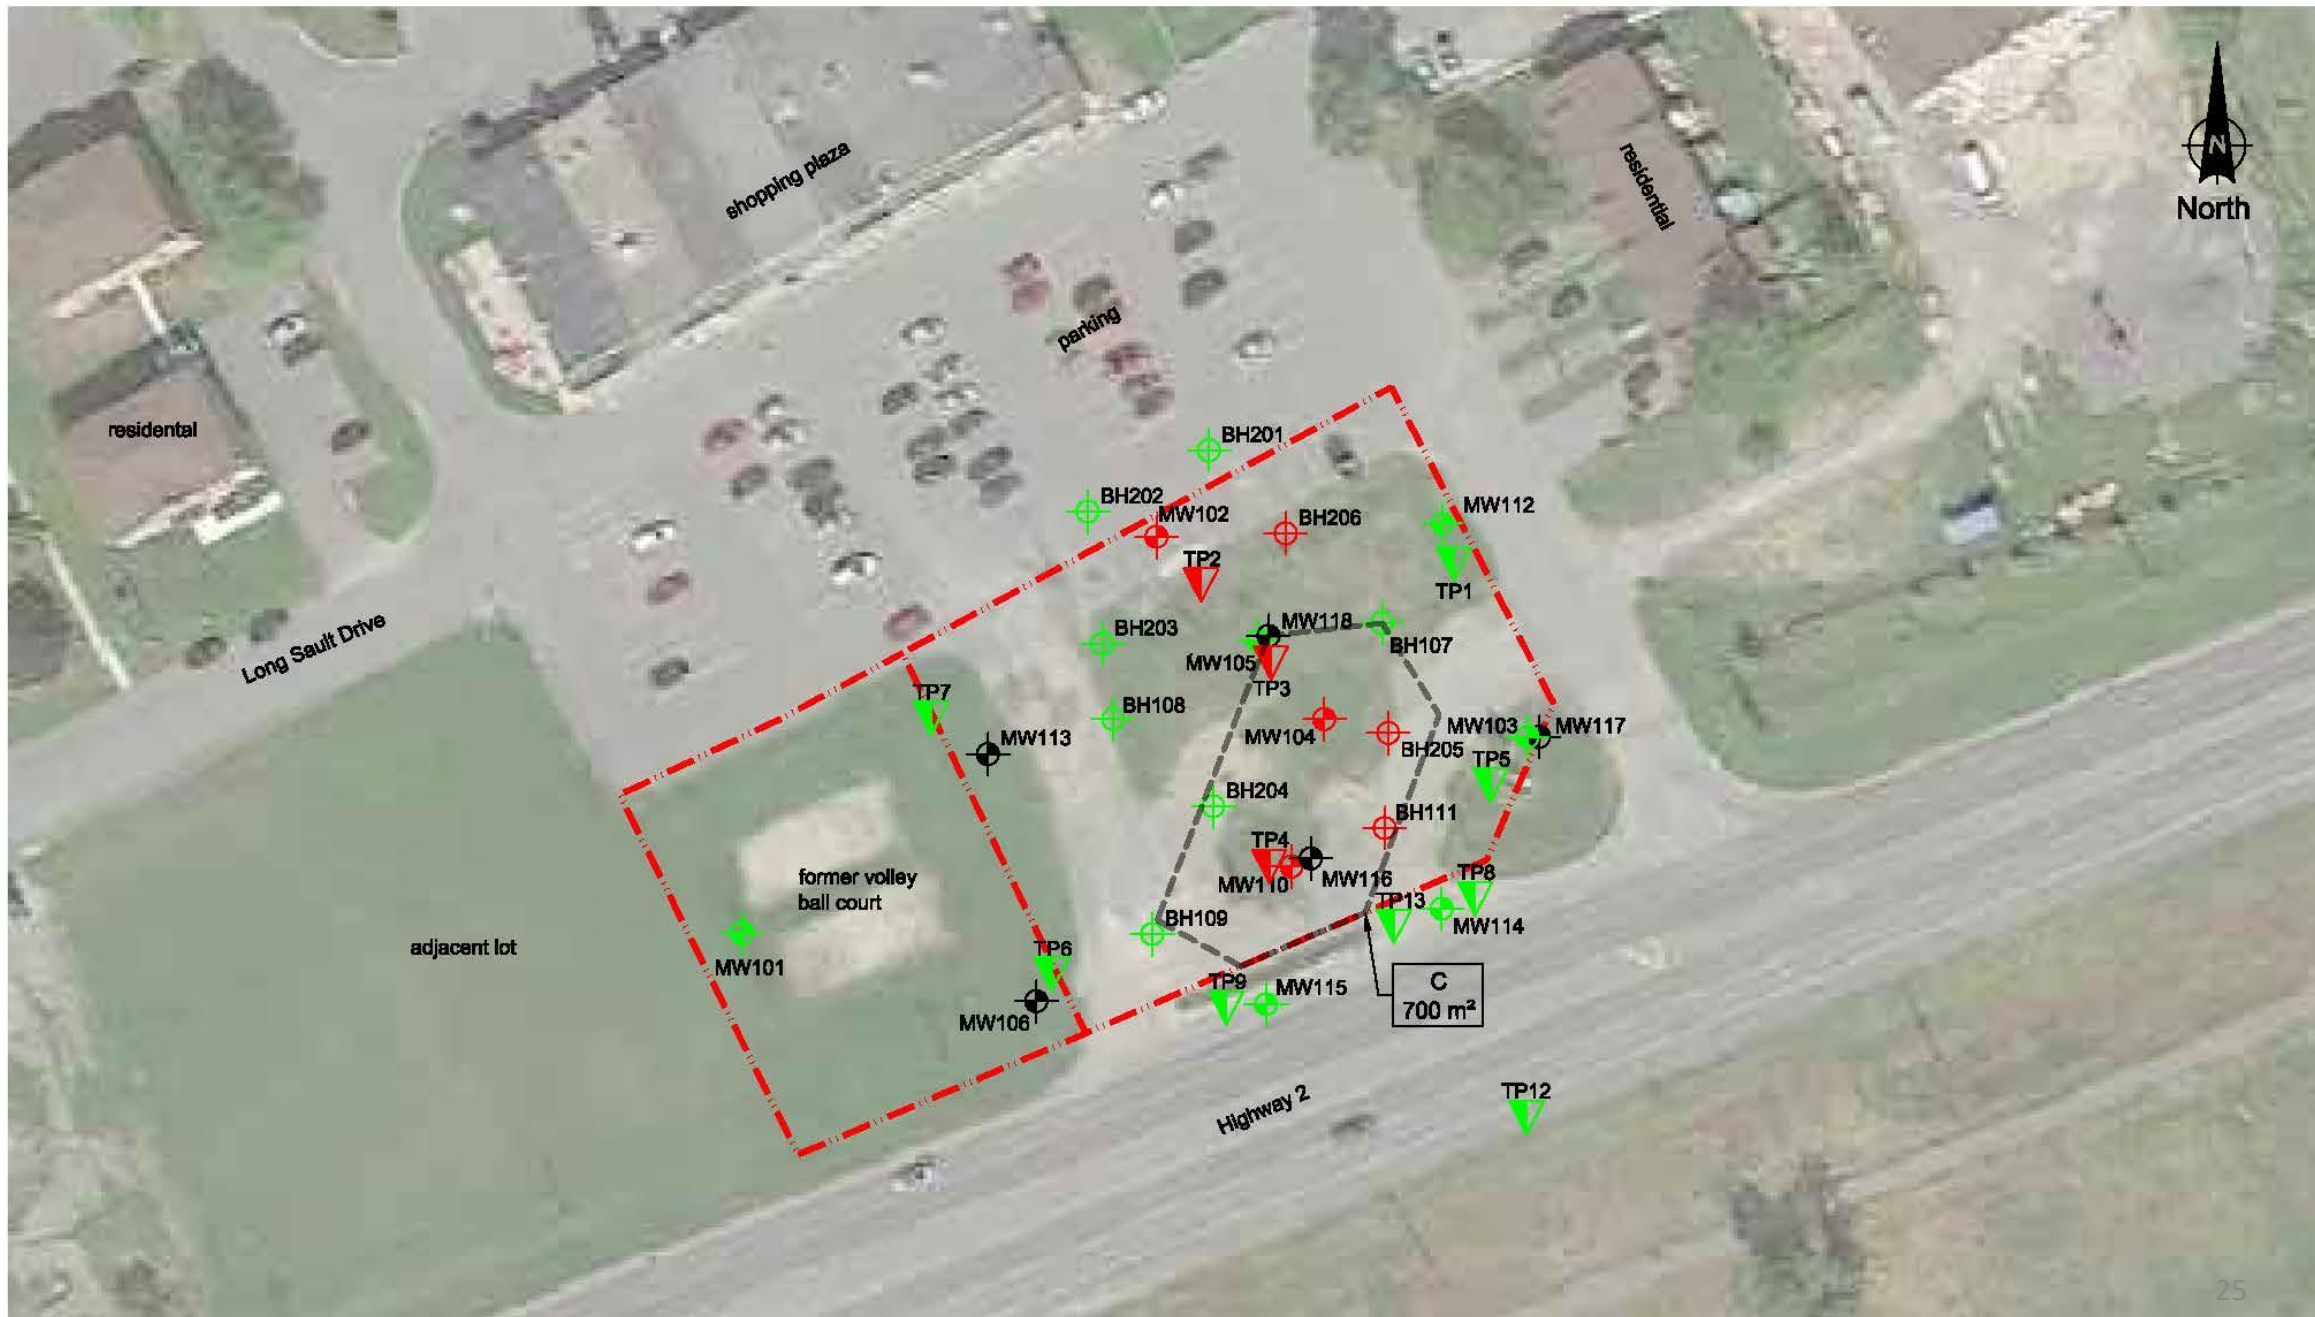
- Review potential remedial options (to obtain an RSC)
- Provide a related cost estimate
- Three approaches considered:
 1. Excavation to “clean” conditions (applicable standards)
 2. Excavation to risk-based standards
 3. “Hot-spot” excavation and remediation of residual contamination in place (*in situ*)
